18th Annual Technical Forum
Geohazards Impacting Transportation in Appalachia

Working Against Gravity: Mitigating Rock Slopes and Landslides in Westernport, MD

Matthew B. Morris, P.G. & Joseph T. Krupansky, P.G.
Gannett Fleming, Inc.

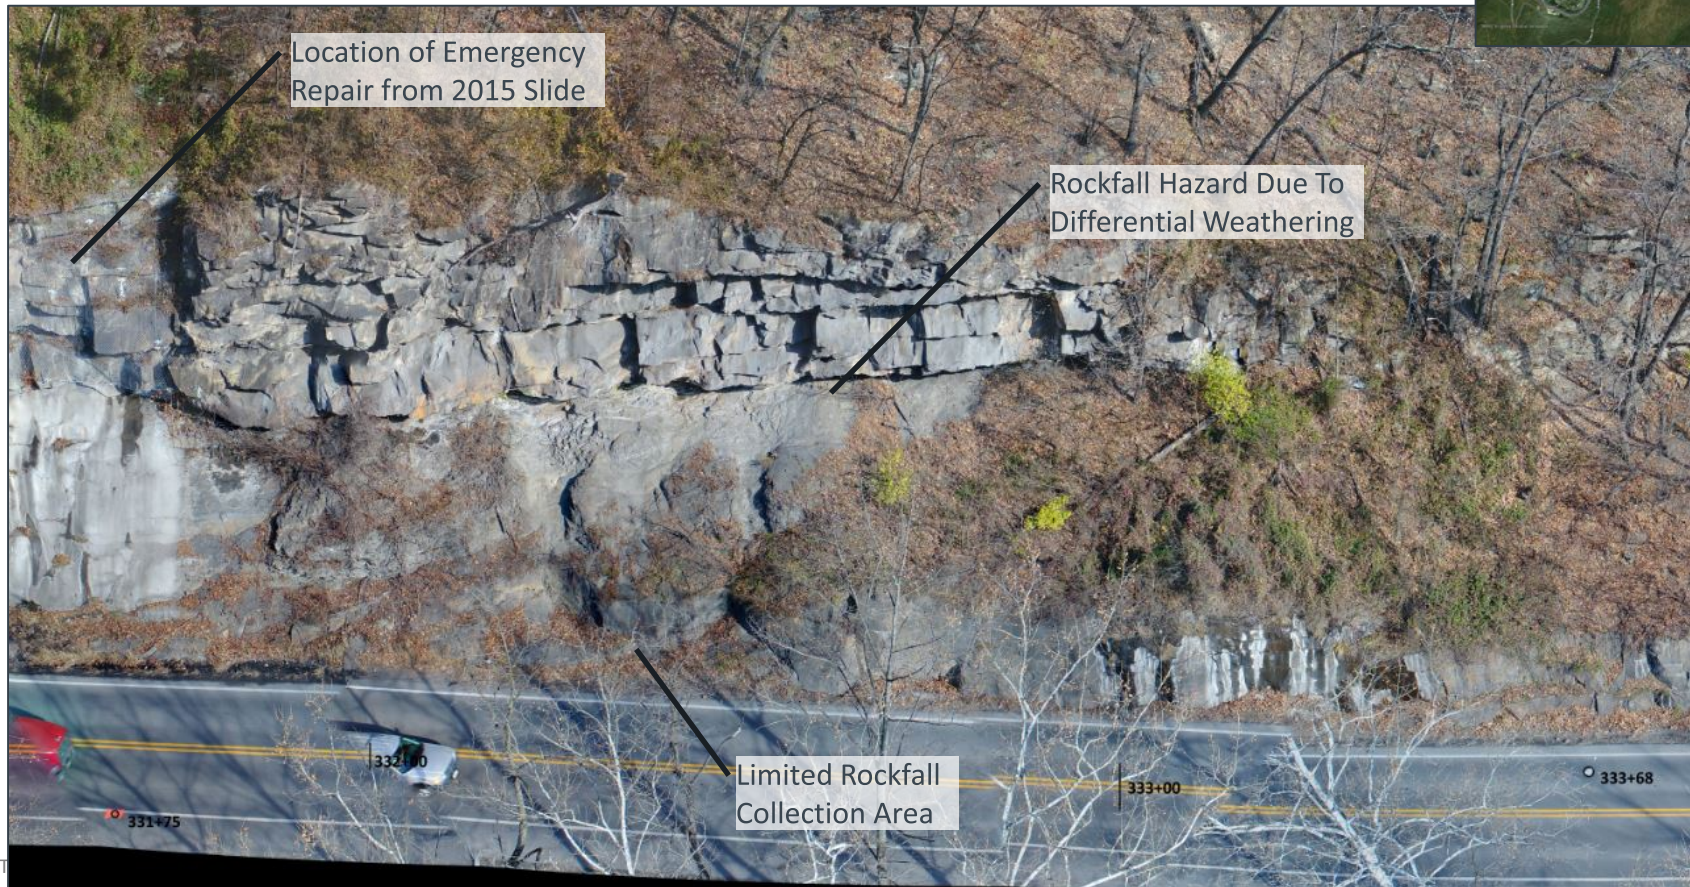
Slope Section 2

Location of Emergency Repair from 2015 Slide

Rockfall Hazard Due To Differential Weathering

Limited Rockfall Collection Area

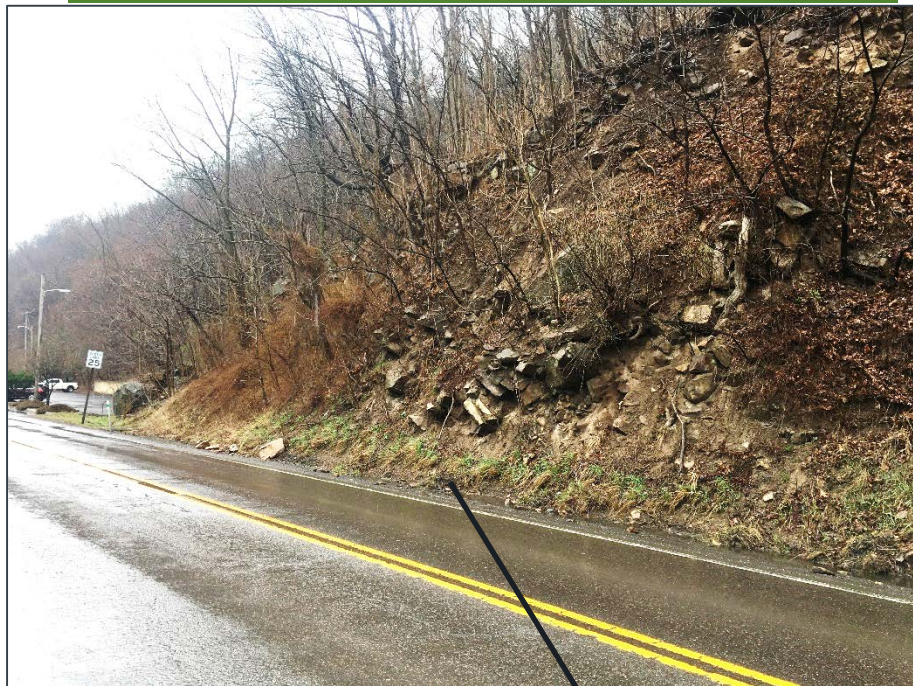
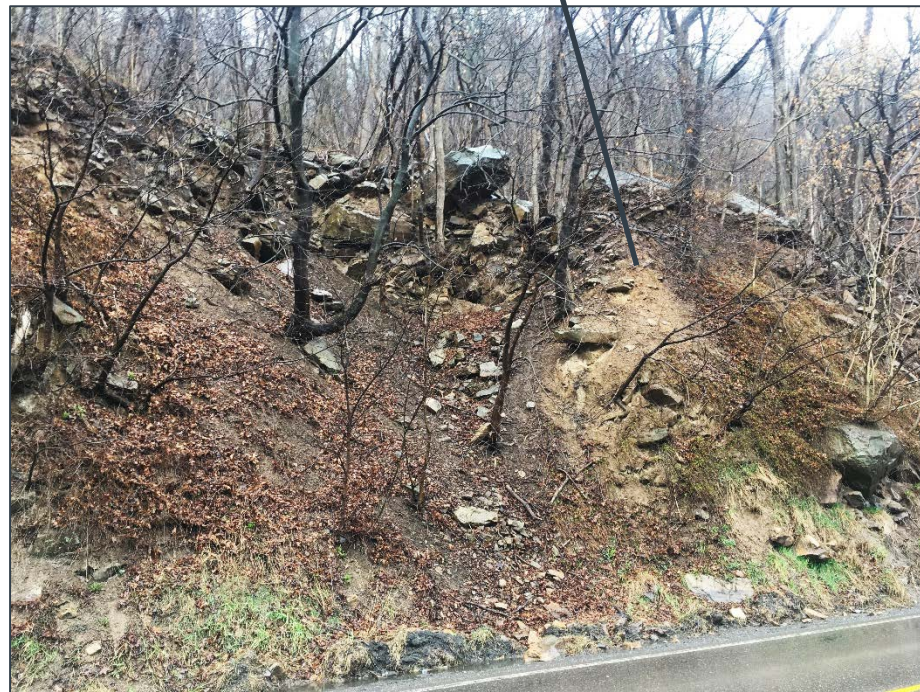
Slope Section 7

Limited Rockfall
Collection Area

Rockfall Hazards Due To Erosion of Fines
Allowing Boulders to Roll Out of Slope

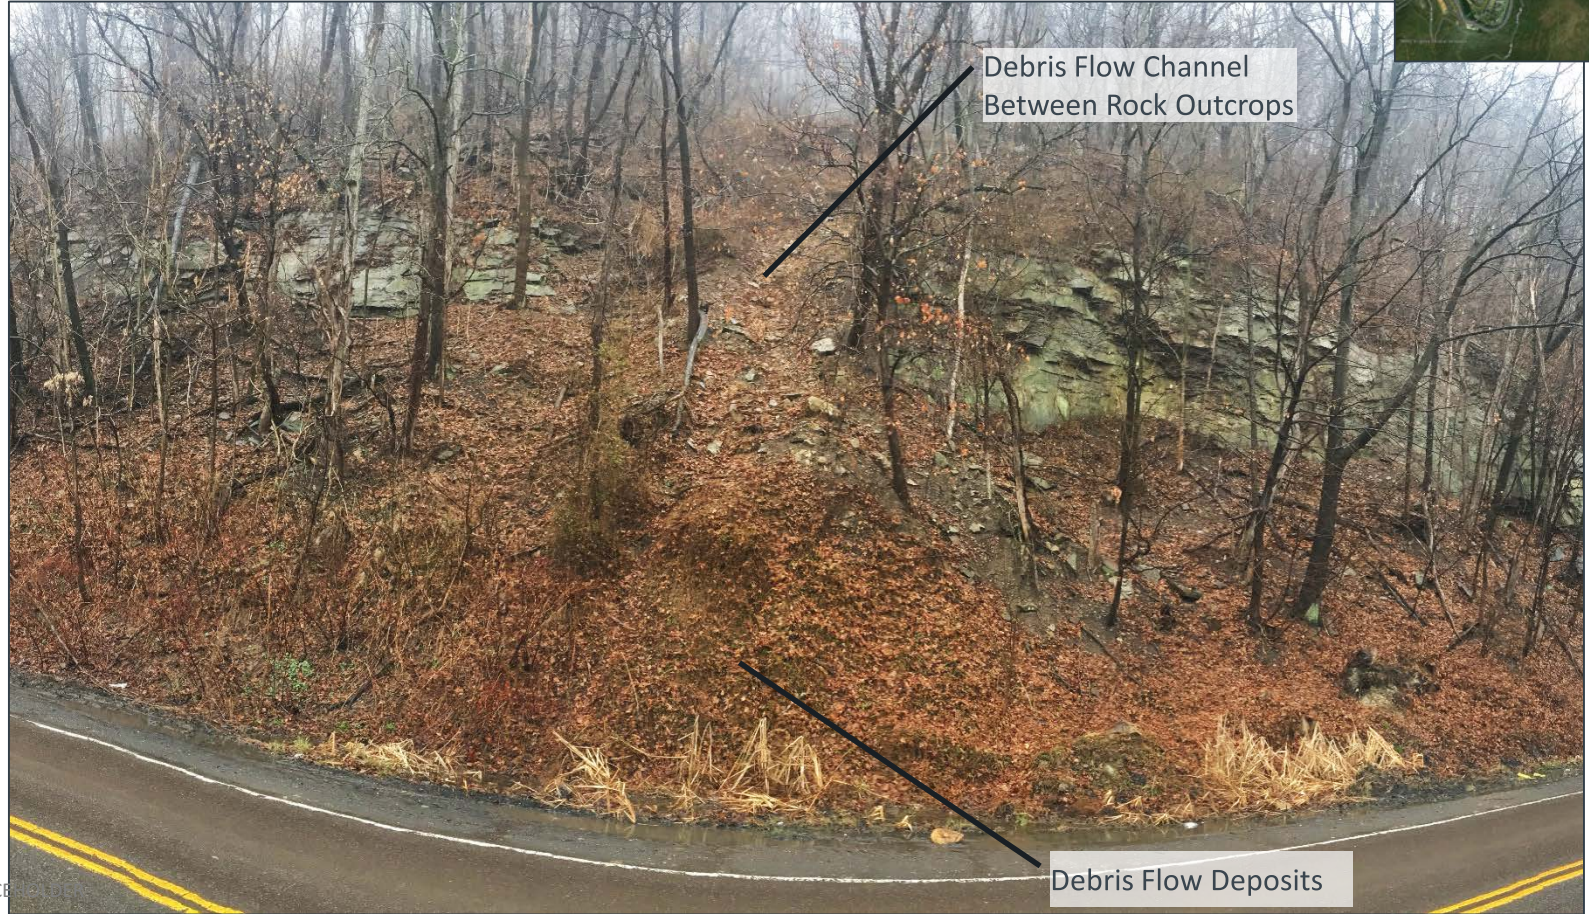
Slope Section 9

Debris Flow Channel
Between Rock Outcrops

Debris Flow Deposits

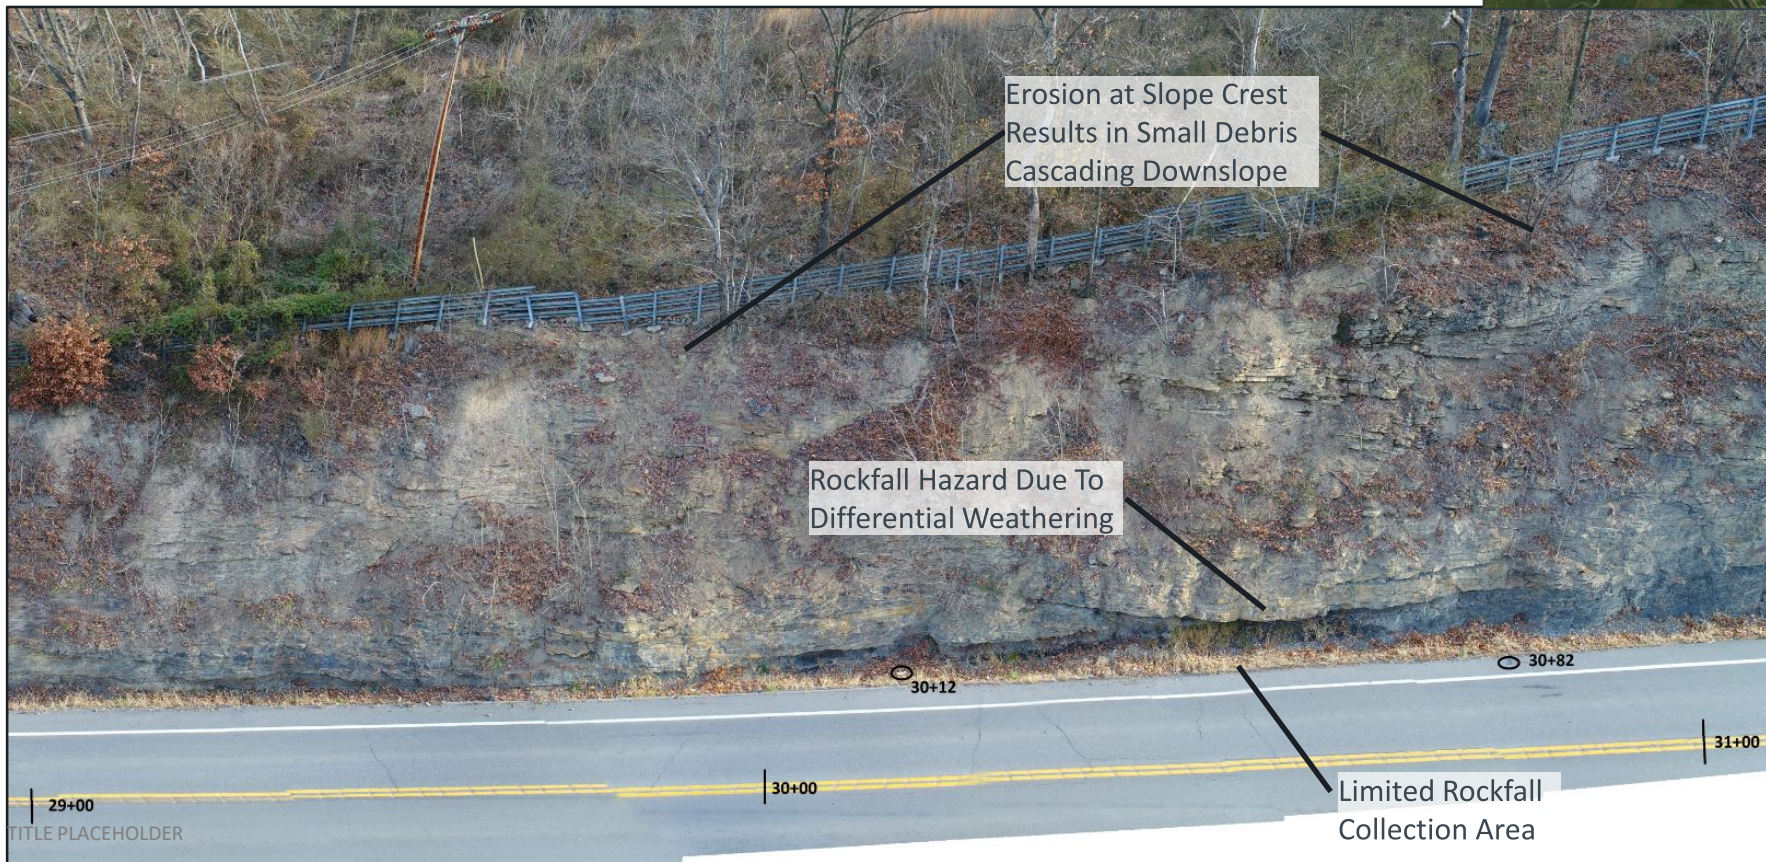
Slope Section 14

Erosion at Slope Crest
Results in Small Debris
Cascading Downslope

Rockfall Hazard Due To
Differential Weathering

Limited Rockfall
Collection Area

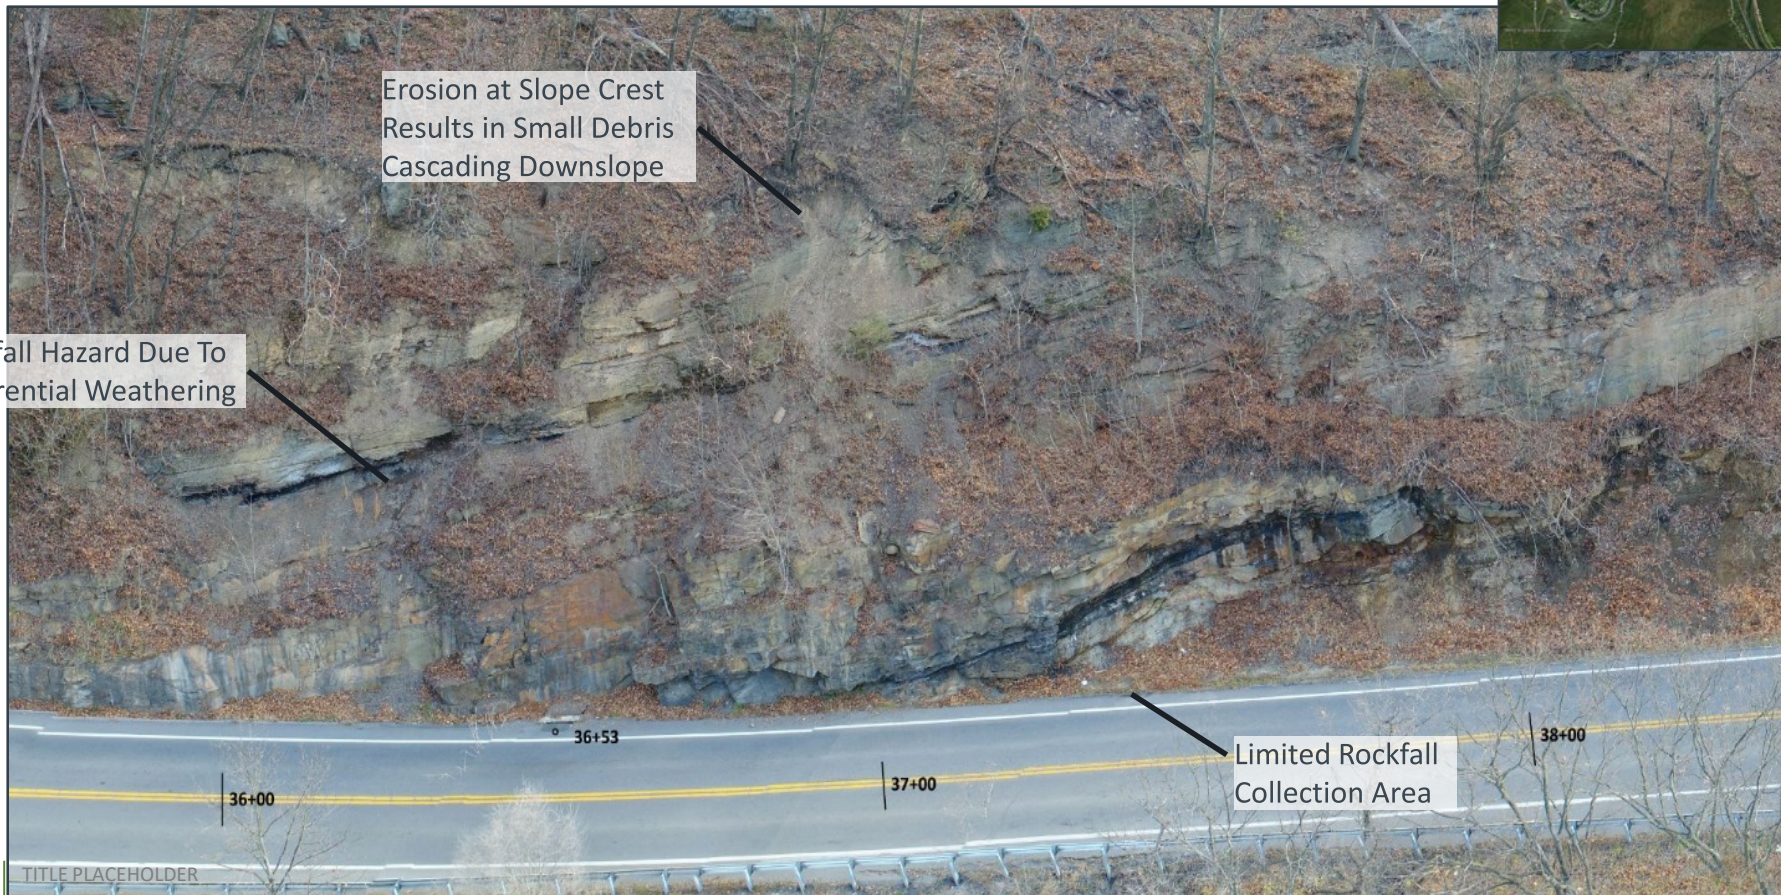
Slope Section 16

Erosion at Slope Crest
Results in Small Debris
Cascading Downslope

Rockfall Hazard Due To
Differential Weathering

Limited Rockfall
Collection Area

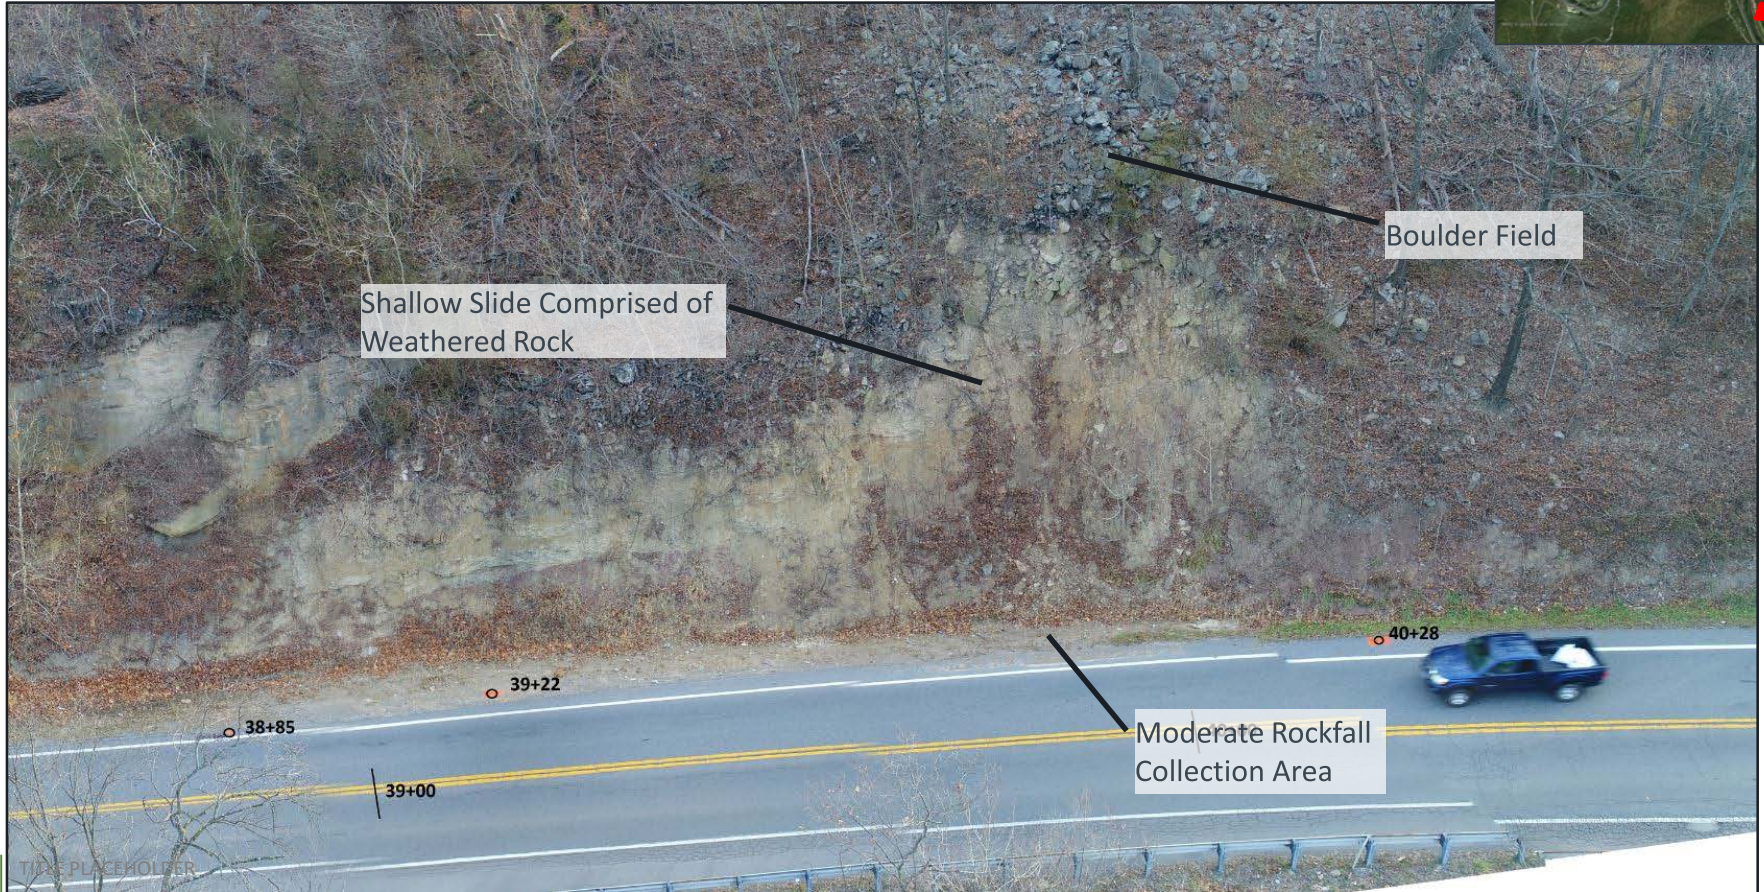
Slope Section 18

Shallow Slide Comprised of Weathered Rock

Boulder Field

Moderate Rockfall Collection Area
